# ANALYSIS OF ARRAY COMPONENTS RECOVERED AT ST. CROIX, VI

Research & Engineering Department

May 1977

NAVTORPSTA Report 1332, *Analysis of Array Components Recovered  
at St. Croix, VI*

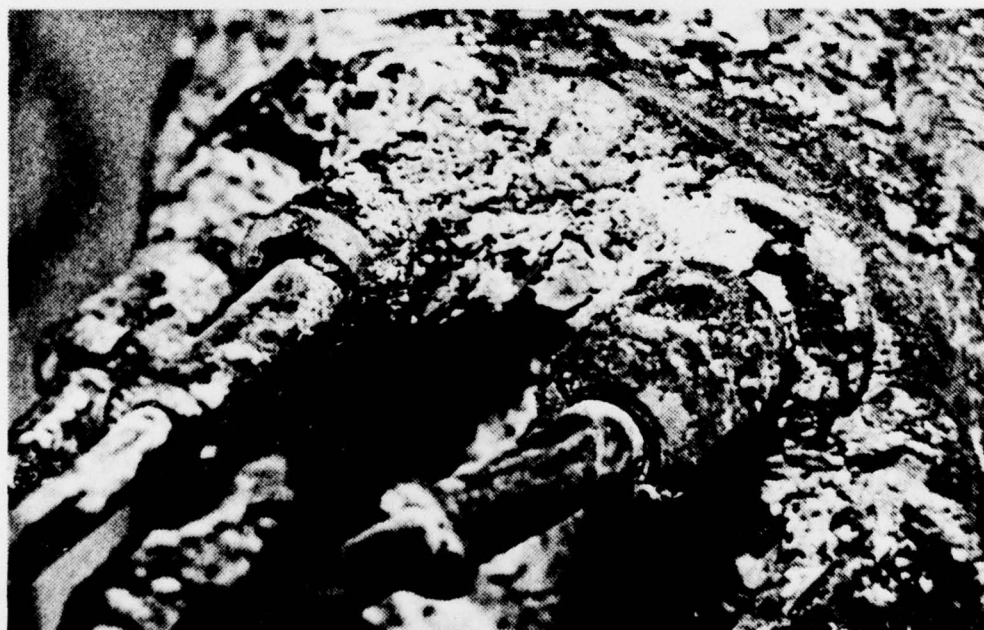
Junction Box. The junction box was heavily corroded on the exterior, with yellow powdery corrosion products accumulated around the Morrison seals of the hydrophone breakout end. See Figure 3. The end plate of the hydrophone side was removed

Figure 3. Exterior Corrosion, Junction Box, Array 7  
(Approx. life size)

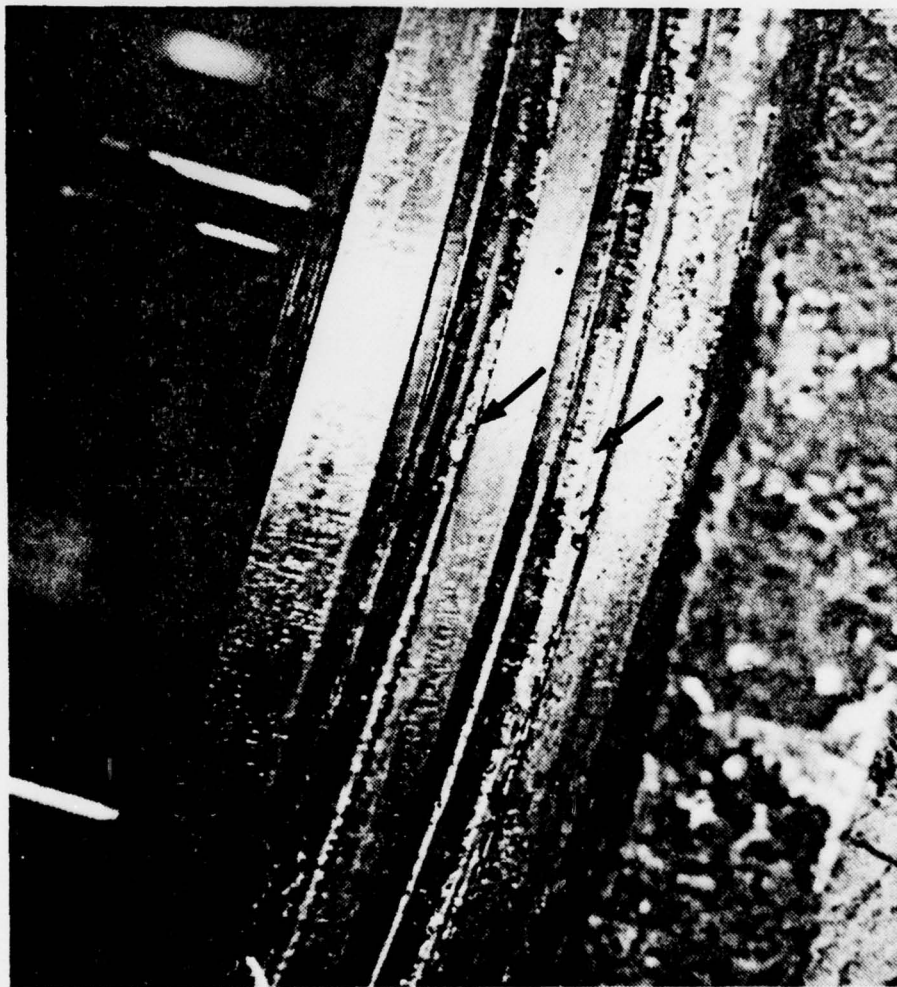
first. Very little corrosion was evident at the sealing surface to the first O-ring. The O-rings had a moderate amount of grease on them, as can be seen in Figure 4. The inside surface of the end plate had a dull green coating which, a discussion with APL personnel indicated, was a proprietary dichromate sealing finish used on zinc-plated surfaces.

Figure 4. End Plate O-rings, Junction Box, Array 7  
(Enlarged)

The O-ring surface of the mating housing surface was lightly corroded in spots up to the first O-ring. No corrosion was found on the interior side of the first O-ring, indicating that no water got beyond that seal. The end plate at the main cable end of the junction box was removed. Again corrosion had reached only to the first O-ring of the double O-ring seal. The O-rings were lubricated with a moderate amount of grease.

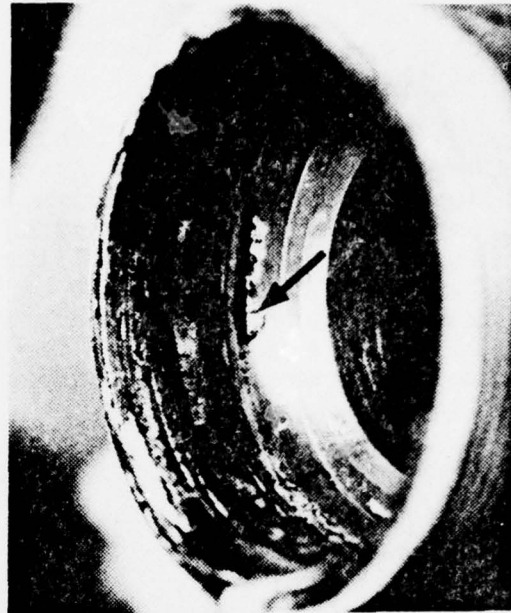
Morrison Seals. The Morrison seal of the main cable was inspected. The O-ring seal of the Morrison seal body was corroded to a maximum depth of 1.241 inches at one point, which is beyond the second O-ring; however, no water was found in the seal area (see Figure 5). The O-rings were fairly heavily greased. The grease on the outer O-ring had become a chalky white due to exposure to seawater. This condition has also been observed on components recovered at NAVTORPSTA ranges. The O-ring squeeze was found to be about 12 to 13 per cent, which was about one-half that of the squeeze at the preamplifier seals. The observed dimensions were found to be in accordance with a detailed drawing of the part.

Figure 5. O-ring Surface,  
Main Cable Seal  
(Approx. life size)

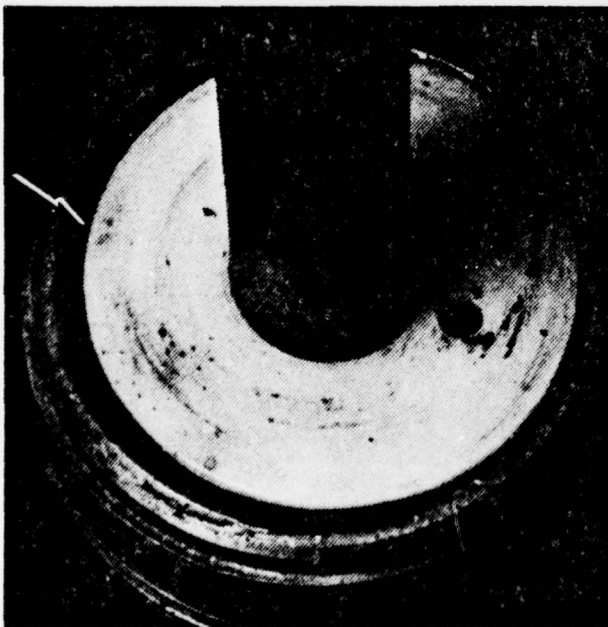
The back-up washer at the face of the first Morrison seal was slightly off center, causing the seal to extrude slightly at one side. (See Figure 6). Water which apparently entered along the gland wall, was found under the third main seal. Corrosion depth in the Morrison seal gland was 1.724 inches from the top of the gland. The corrosion line reached to the middle of the third seal. Water was also found at the solder cup, where the cable shield is attached to a feed-through pin.

Figure 6. Extruded Seal, Main Cable Seal  
(Approx. life size)

The water found in the solder cup evidently entered the severed end of the cable during re-submergence. Supporting this observation, water was found along the complete length of the cable stub attached to the seal.

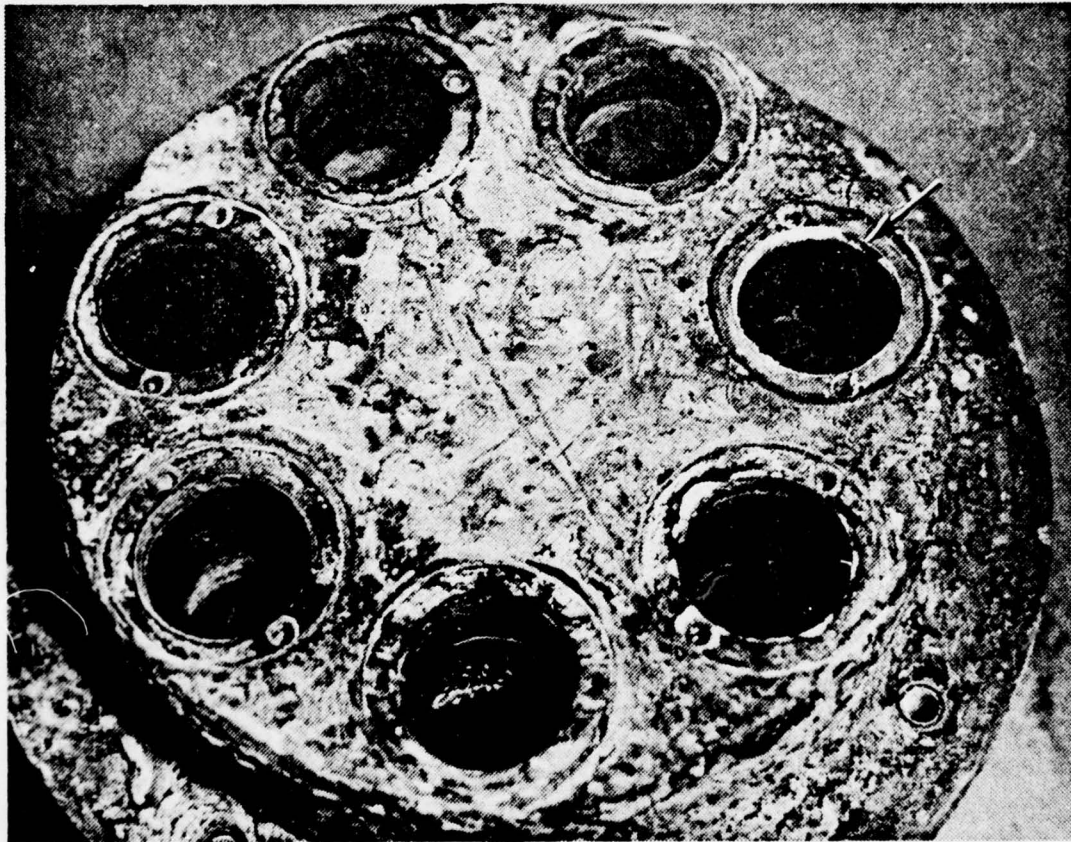
The interconnect cable Morrison seals at the junction box were disassembled and inspected. Of primary interest was the depth of the corrosion in the glands. The depth of a complete seal is 2.450 inches. The average corrosion depth as measured in six glands was 1.278 inches. The deepest corrosion was 1.683 inches to a point on the gland wall beyond the third seal. It is interesting to note that the spare hole, sealed with O-rings on a metal plug, was corroded only to the chamfer at the hole entrance. The spare hole is at the 2 o'clock position in Figure 7.

Figure 7. Morrison Seal Glands, Junction Box, Array 7  
(Approx. life size)

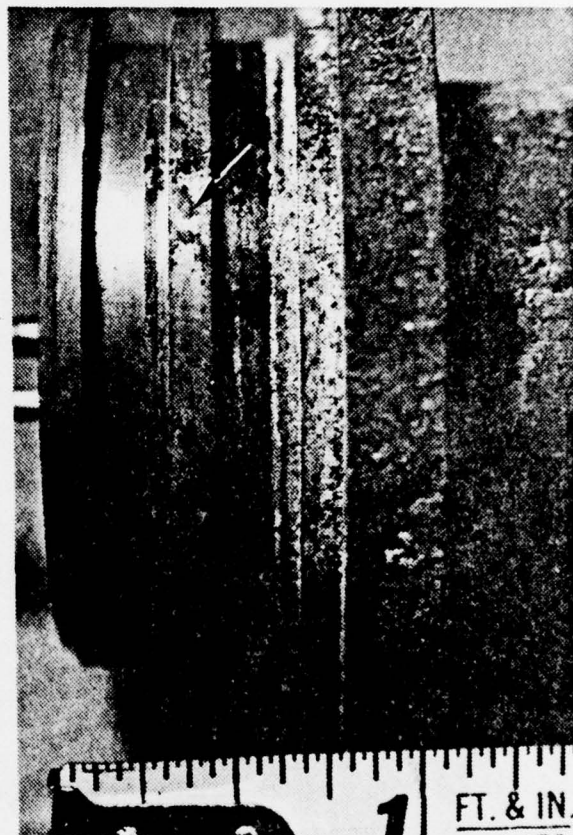
Preamplifiers. No water leaked beyond the second O-ring of any of the preamplifiers. However, some moisture had leaked past the first O-ring of the cable seal end caps. This was evidenced by slight corrosion of the surface between the two O-rings of the cable seal end caps of the c, x, xy, and UQC preamplifiers. Figure 8, a photograph of the x preamplifier cable seal end cap shows this condition. The hydrophone end of the preamp is capped by a similar double O-ring seal. These showed no leakage past the first O-ring in any of the preamplifiers. Figure 9 is a photograph of the x preamplifier hydrophone end cap seal. The scratches on the lands were made during disassembly. It was noted that the O-ring surfaces of the end caps had two types of finishes: some the dull green type mentioned earlier, and the others a bright gold type. The bright gold-colored surface is a sodium dichromate seal finish used on zinc plate. There appeared to be no difference in corrosion protection between the two types of finish.

Figure 8. Corrosion Between O-rings,  
X Preamplifier Cable Seal End Cap  
(Enlarged 2X approx.)

1. The only leak past a double O-ring occurred where the O-ring squeeze was 12 per cent versus 23 per cent at other O-ring seals. It is recommended that the higher squeeze be used to achieve a longer service life.

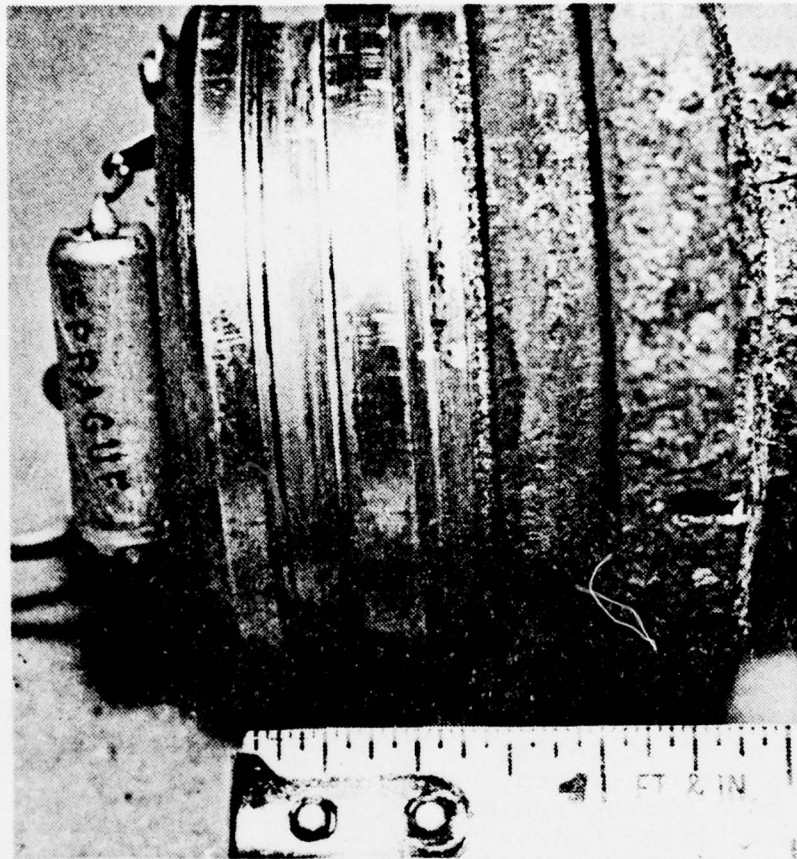
The O-ring squeeze of the preamplifier seals was determined by measuring the outboard groove/gland dimensions and the corresponding O-ring dimensions. The average squeeze was about 23 per cent on the cable seal end and 24 per cent on the hydrophone end. The lubrication, or amount of grease, on the O-rings on both ends appeared to be about equal. All O-rings had back-up rings.

Figure 9. O-ring Seal Surface, X Preamplifier Hydrophone End Cap  
(Enlarged 2X approx.)

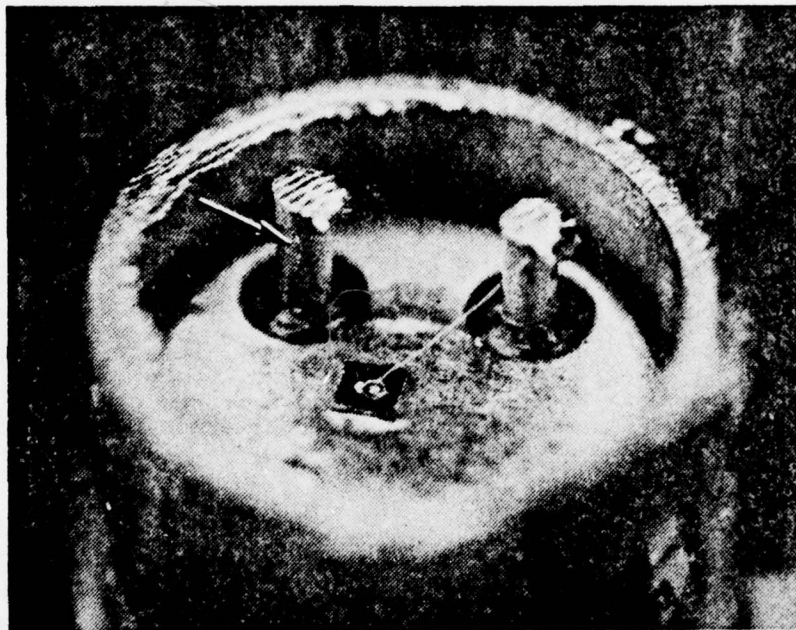
The array was recovered because of malfunctioning of the c and x preamplifiers. Bench tests of the c preamplifier indicated its failure was due to an open in the base of the first input transistor, Q1, a 2N2484. The transistor can was cut open and it was found that the lead to the base junction of the transistor had melted, thus creating an open to the base. See Figure 11. The failure of the x hydrophone was not

Figure 11. Open Contact in Q1 Transistor  
(Enlarged 19X approx.)

The malfunction of the c preamplifier was due to an open in the base junction contact of the Q1 input transistor. The x preamplifier failure most probably was due to a low-resistance path between the shield and center conductor. Crevice corrosion at the seal gland progressed past three rubber seals into an area where seawater created a conductive path between the conductors.

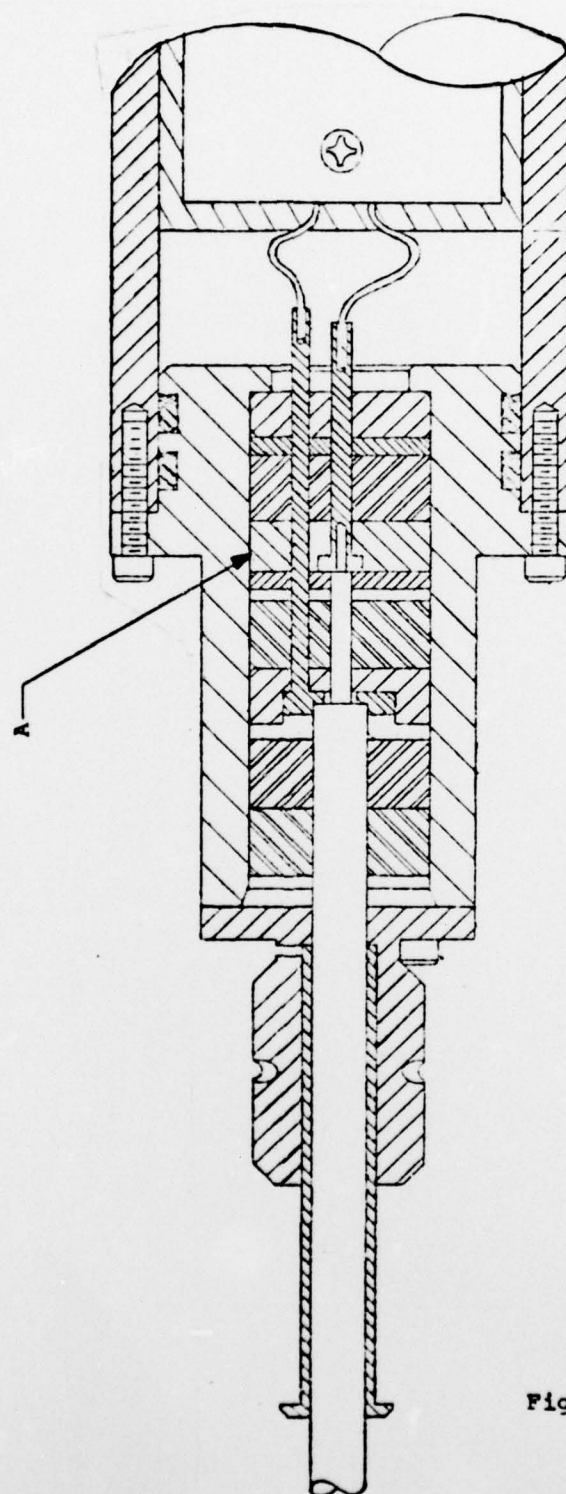
so clear cut. The preamplifier was tested on a bench but no malfunction was apparent. However, the interconnect cable had a resistance of 29k ohms between shield and center conductor prior to disassembly of the housing. With the ohmmeter polarity reversed, the resistance was 52k ohms. This difference indicates a small battery action which occurs with seawater leakage. This resistance was taken after the cable and seals had been out of the water for 3 months; the resistance when the array was in the sea is not known. Corrosion in the seal gland at the preamplifier indicated that moisture had reached the point where the center conductor and shield are separated just ahead of the last seal. This is shown as A in Figure 12. Moisture at that point resulted in a conductive path between the two conductors. The effect could range from no signal to a very noisy signal from the preamplifier depending upon the resistance of the path.

Figure 12. Corrosion Area,  
Morrison Seal

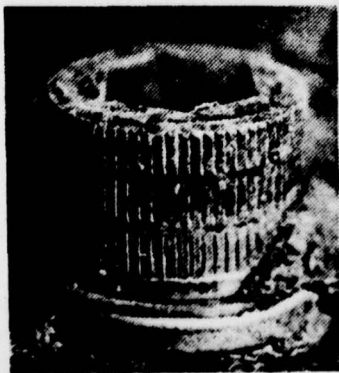
Figure 14. Hold-Down Screw  
on Tilt Housing  
(Enlarged 2½X approx.)

Tilt Housing. The exterior of the housing was heavily corroded with red-brown to yellow-brown layers. See Figure 13. However, the 3/8-16" stainless-steel hold-down screws were uncorroded; see Figure 14. On removal of the housing cover, about

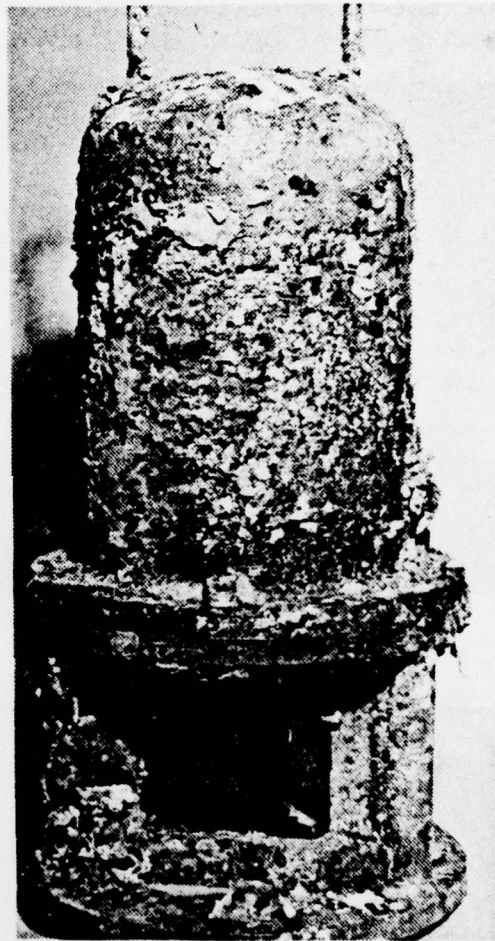
Figure 13. Tilt Housing, Array 10  
(0.23X approx.)

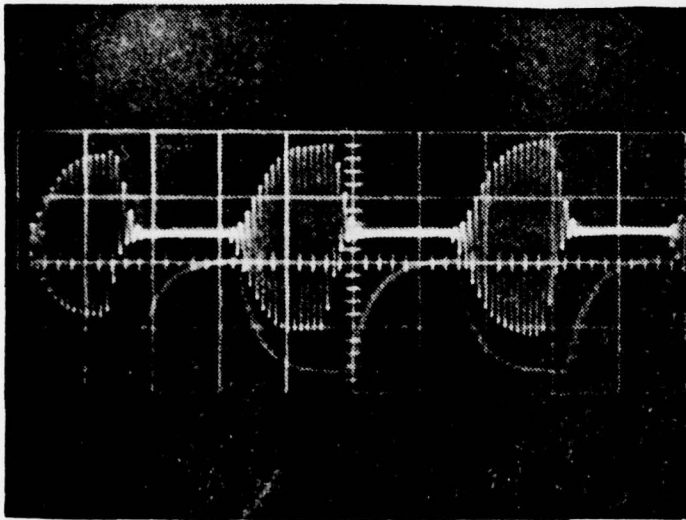
3 to 4 ounces of oil spilled out. The oil had come from the two pendulum housings (behind the circuit boards). The oil acts as a damping fluid for the tilt pendulums. The tilt housing had been shipped in an inverted position and the oil leaked through the synchro transmitters which are mounted on the housing above the normal oil level. A visual inspection of the tilt circuit board revealed no defects. The circuit was powered up on the bench and the output signal observed

Figure 15. Tilt Output Waveform  
Observed in Bench Test

on a Tektronix 545 oscilloscope. The output at the cable terminals with the pendulums in a level attitude was a 20-kHz sine wave on a pulsed frequency of 588 Hz. The peak-to-peak output level was about 3 volts with 28 volts dc power. See Figure 15. The lower sawtooth wave is the output of the unmodulated synchro transmitter. Operation of the tilt circuit appeared normal. As a comparison Figure 16 shows the output as was seen at the computer site at St. Croix when the array was still on the range.

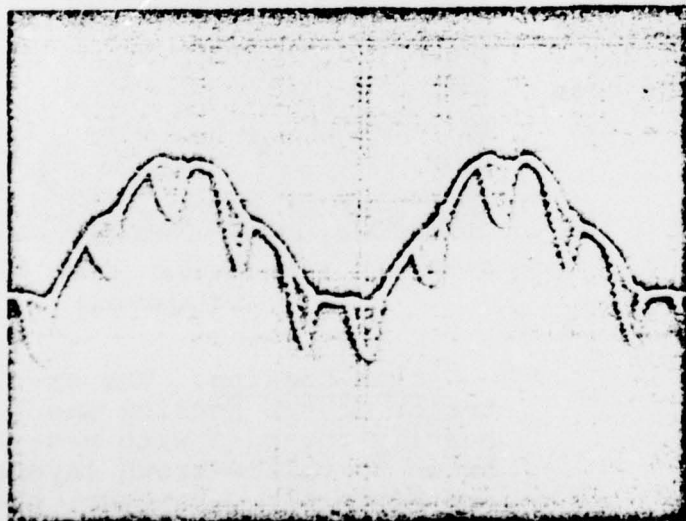
Figure 16. Tilt Output  
Observed at St. Croix

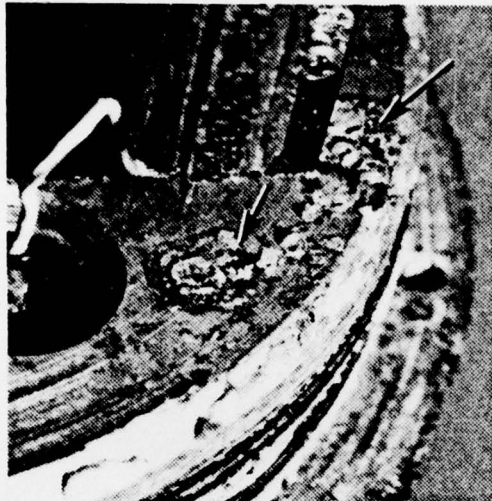
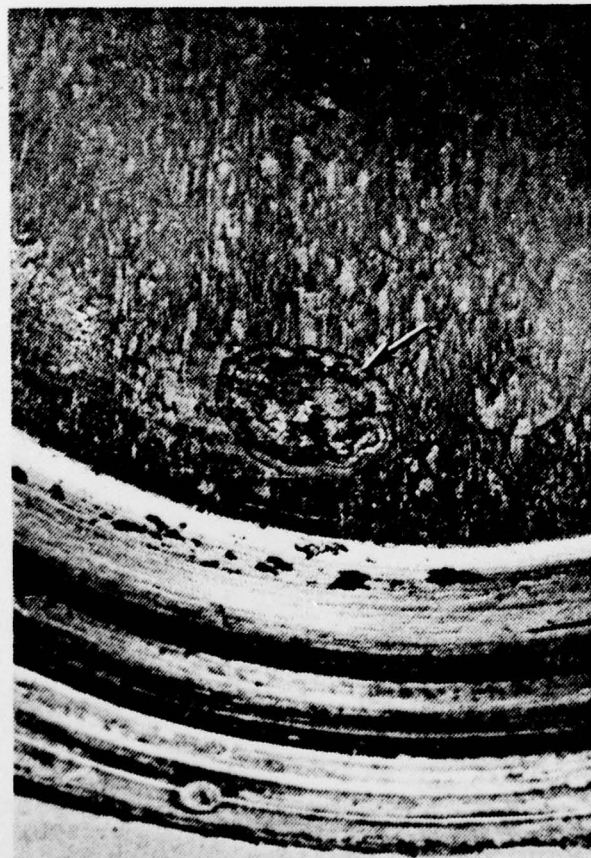
The main junction box exterior was heavily corroded with red rust and a yellow powdery residue around the interconnect cable seals. The j-box housing was oil filled, which is unusual. Some corrosion was noted in the interior at the interconnect cable end plate and on the housing wall, which had two dime-size spots. These corrosion areas appeared to be isolated and not a result of a seawater leak.

Figure 17. Corrosion on End Plate, Main Junction Box (Enlarged)

Figure 18. Corrosion in Housing, Main Junction Box (Enlarged)

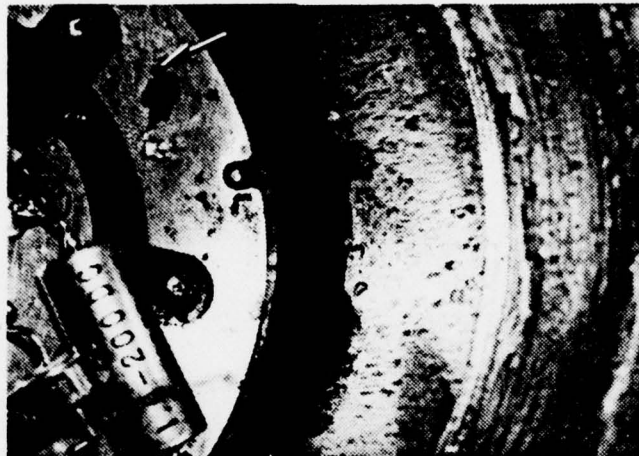
(See Figures 17 and 18.) A corrosion spot was also seen on the printed circuit board which was mounted on standoffs on the end plate. (See Figure 19.) This indicates that some moisture may have been in the oil at the time of installation. The double O-ring seals of the end plates were heavily greased. Some corrosion was evident in the O-ring grooves but was irregular; see Figure 20. Seawater corrosion of O-ring surfaces ordinarily advances along a line roughly parallel to the grooves, as in Figure 21.

Figure 19. Corrosion on Circuit Board,  
Main Junction Box (Enlarged)

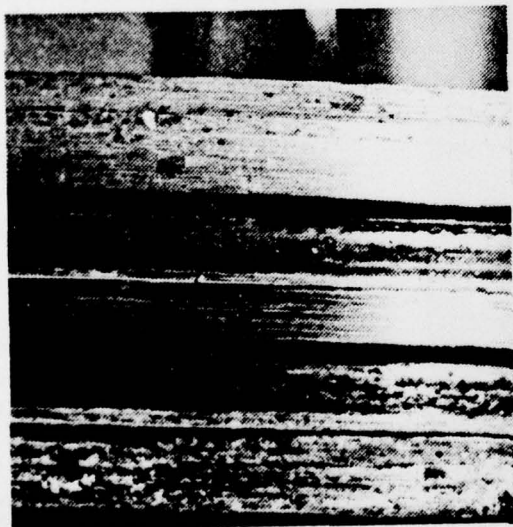
Figure 20. Corrosion of O-ring Surfaces,  
Main Cable End Plate (Enlarged)

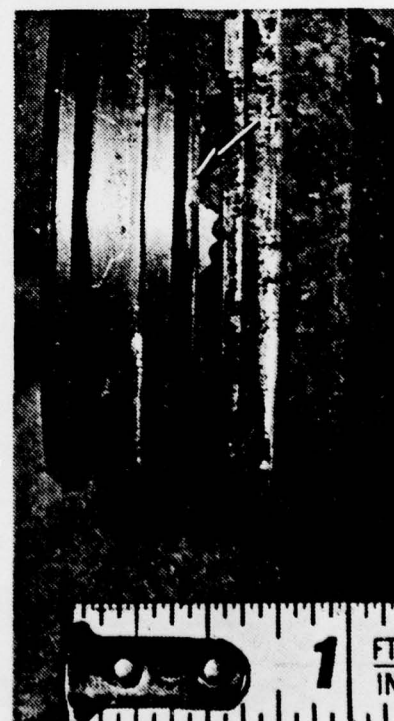
Figure 21. Corrosion of  
O-ring Surface,  
C Preamplifier Cable Seal  
(Enlarged 1.5X)

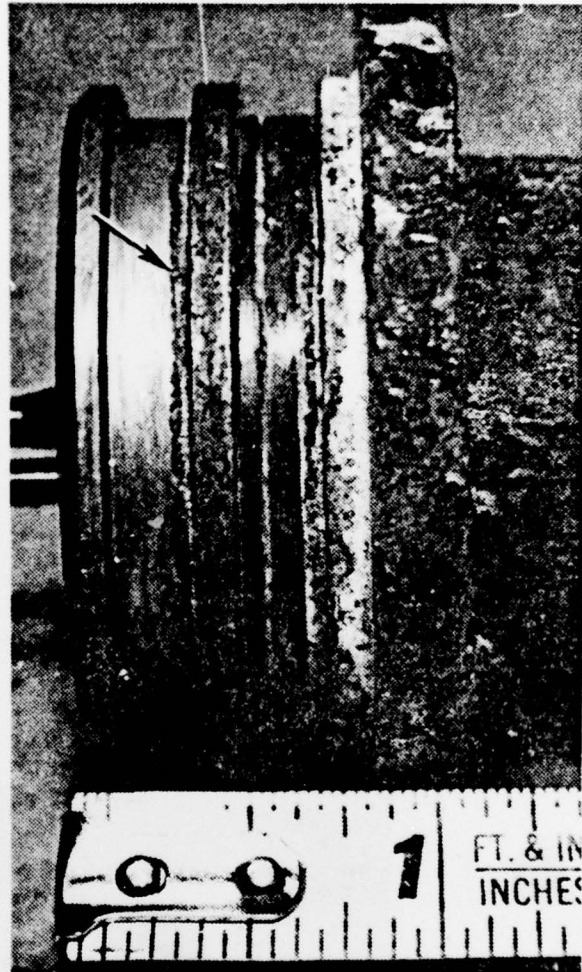
In the case of the x preamplifier cable seal end cap, corrosion reached the second O-ring (see Figure 22). The O-ring glands of the housings were corroded to the depths corresponding to the corrosion on the plugs, as shown in Figure 23 for the c preamplifier. The c preamplifier had a ruptured capacitor (Figure 24) in the tuning circuit. This was a 0.1-microfarad capacitor rated at 200 Vdc. It provided ac ground to seawater on the secondary side of the hydrophone tuning circuit to prevent oscillation in the preamplifier circuit. The failure is believed to have been caused by the high voltage surge of a lightning strike. Strikes had occurred in 1968 and 1973. The resistance across the damaged capacitor was 1 megohm. This would not have materially affected functioning of the preamplifier.

Figure 22. Corrosion of O-ring Surface, X Preamplifier Cable Seal (Enlarged 2X)

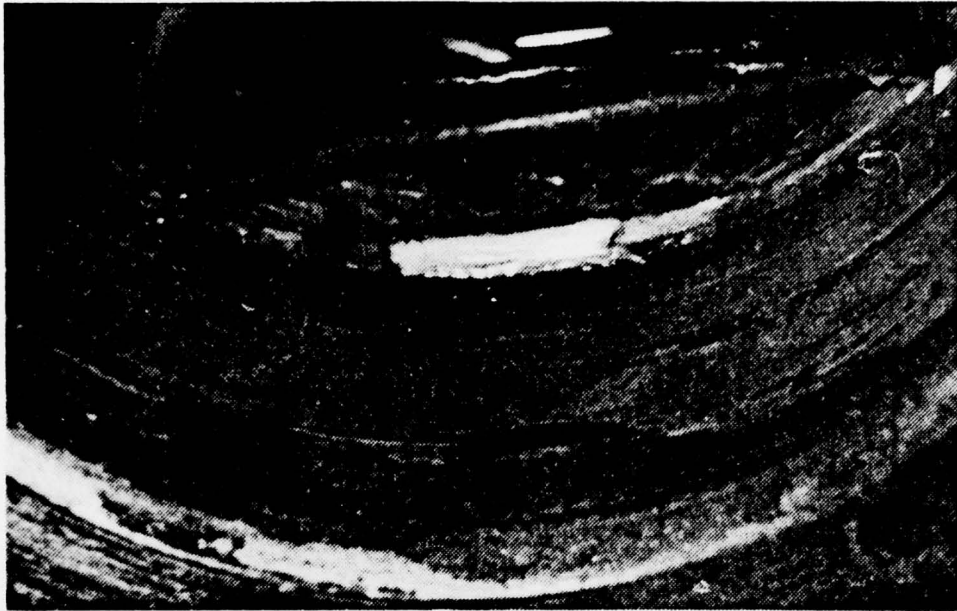
Figure 23. Corrosion of O-ring Gland, C Preamplifier Housing  
(Enlarged)

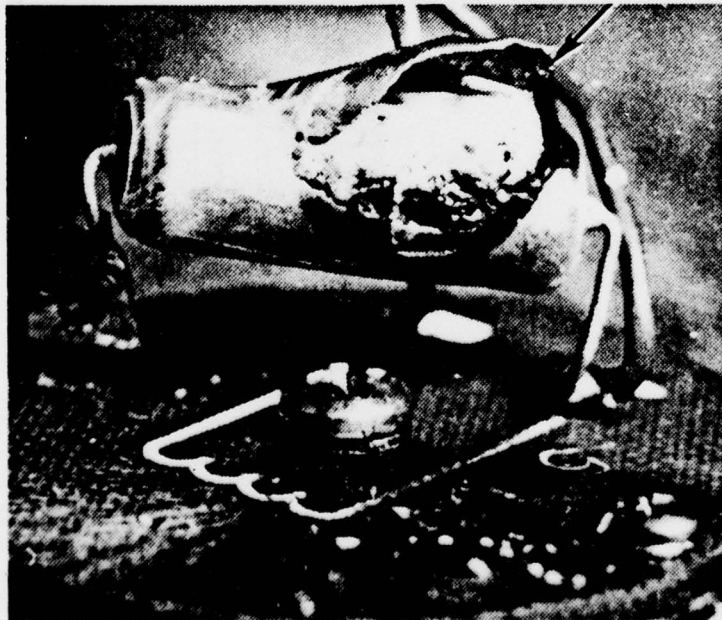
Figure 24. Ruptured Capacitor, C Preamplifier  
(Enlarged)

Lightning damage was apparent in the c preamplifier, which sustained a burned grounding capacitor at the secondary of the hydrophone tuning transformer.

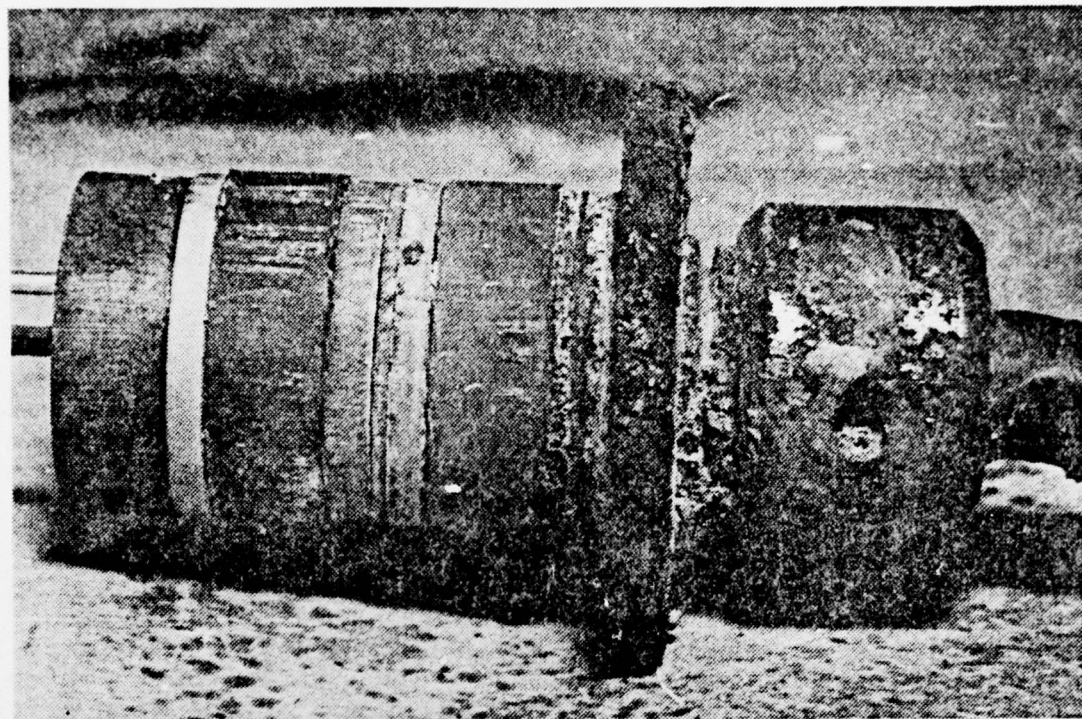
The corrosion in the gland of the main cable seal had progressed 1.238 inches into the seal to the point at which the shield is soldered to a feed-through pin. Figure 25 is a photograph of the seal, whose overall length was 2.4 inches. Water was found at the shield termination but little corrosion had occurred there. Since the main cable had been cut and the array subsequently re-submerged for towing to shore, the water probably entered along the shield from the cut. However, the corrosion path along the gland wall indicates that some water entered at the wall.

Figure 25. Main Cable Seal, Array 10 (Approx. life size)

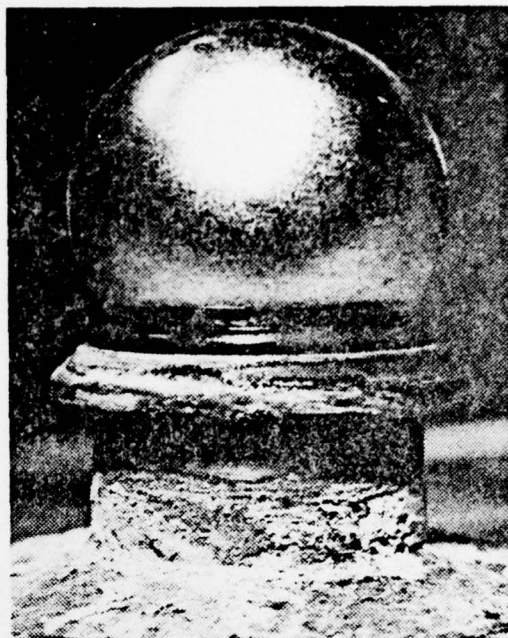
Hydrophone Seals and Transducer. The rubber boots sealing the transducer mounted atop the preamplifiers were inspected. All five hydrophones evidenced water leakage to the O-ring from the wire-wrapped seal at the base of the boot. Figure 27 is a photograph of the xy hydrophone without the boot, which fits over the O-ring and the rounded flange at the base of the

Figure 27. XY Hydrophone, Boot Removed  
(Enlarged 1.4X approx.)

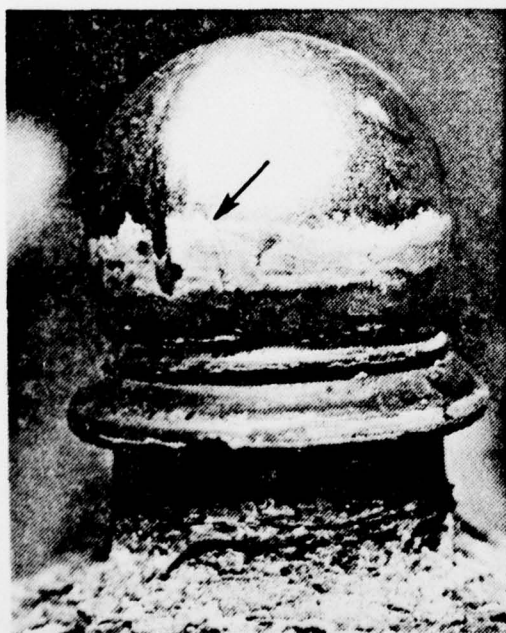
Figure 28. Watermark  
on Lower Side of Sphere,  
C Hydrophone (Enlarged 1.4X approx.)

Three of the five hydrophones showed evidence of water leakage at the boot. Watermarks were visible on the transducer elements above the mounting pedestal.
